**Flood Control Project Maintenance
Levee Inspections**

Fall 2018 Levee Maintenance Deficiency Summary Report

**Flood Control Project Maintenance
Levee Inspections****LMA District Cover Sheet****Fall 2018 Levee Inspection Results****Reclamation District No. 0563 Tyler Island**

Reclamation District No. 0563 Tyler Island

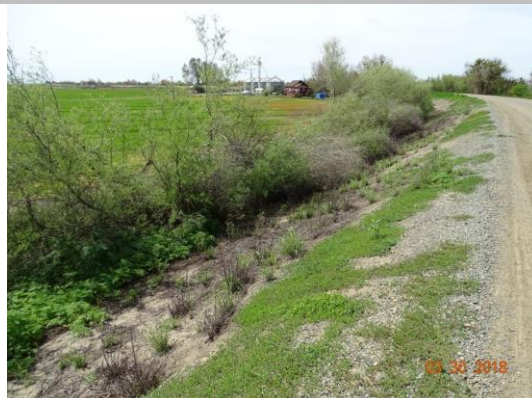
Photo 1 of 1 : FA_2018_RD0563_210_112_20180925_00073.jpg

LM Start	3.11	Rating **	U	Issue No.	112
LM End	3.18	Issue Type +	Ma	Location *	LS
Category	Earthen Levee			GPS Latitude/Longitude	
				Start	End
Item	Vegetation			38.210018 °	38.209495 °
				-121.538353 °	-121.539515 °
DWR ID	DWR_RD0563_01_s_2018_112				
Comment Code					
V7 : Trees / Woody Vegetation					
Inspector Comment					
Dense woody vegetation (up to 6" in diameter) along lower slope and toe prevents inspection and access. Needs to be removed.

Very dense woody vegetation preventing inspection and access to landside toe.

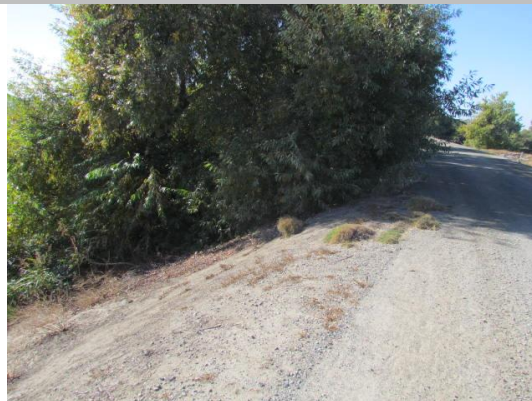
Photo 1 of 2 : FA_2018_RD0563_210_68_20180925_00026.jpg

LM Start	3.21	Rating **	U	Issue No.	68
LM End	3.21	Issue Type +	Ma	Location *	LS
Category	Earthen Levee			GPS Latitude/Longitude	
				Start	End
Item	Trim / Thin Trees			38.209217 °	38.209217 °
				-121.539823 °	-121.539823 °
DWR ID	DWR_RD0563_01_s_2012_68				
Comment Code					
T2 : Thin trees to allow visibility of the ground and room to flood fight.					
Inspector Comment

Looking south at dense trees on landward slope.

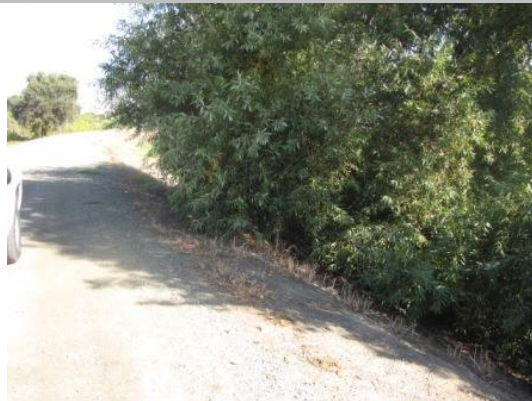
Photo 2 of 2 : FA_2018_RD0563_210_68_20180925_00027.jpg

Looking southeast at dense trees on landside slope and toe.

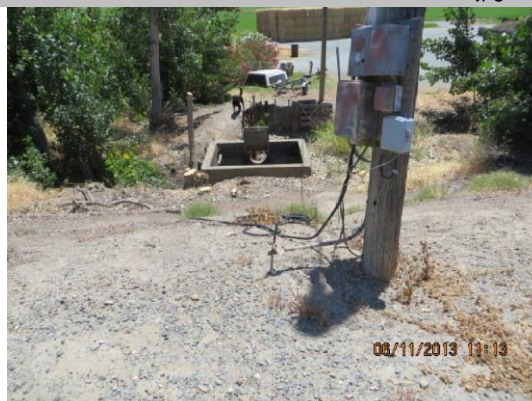
Photo 1 of 3 : UCIP_FA_2018_52755_24550.jpg

Comment Code						
Inspector Comment						
FS_ID:52755 DS_ID:20140 EP_NO: 12708 Repair Type: Non-Urgent Crossing Status: Found UCIP Comments: 07/13/2018 Pump is running, leak detected on intake pipe hanging down the pumping platform toward the slough. (O.Yakimov-DWR UCIP)06/11/2013 Pipe heavily corroded. Good candidate for viewo inspection. FIELD_STRUCT_DESC: 1 of 2: 14-inch coated steel irrigation pipe through the levee, 3 feet below the crown. Slant pump and gate valve on the waterside (WS). 9-foot by 7-foot reinforced concrete distribution box on the landside (LS) toe. Service pole on the LS shoulder. (Permit No. 12708, 1979 - George C. Wilson, replaced 8-inch pipe under Permit No. 11211, 1975 - Erma E. Locke). [Additional Reference(s): DWR Levee Log, 2005. USACE Sacramento O&M Manual 103, June 1954]. FS Date: 7/13/2018 10:26:03 AM

Distribution box and JP on LS.

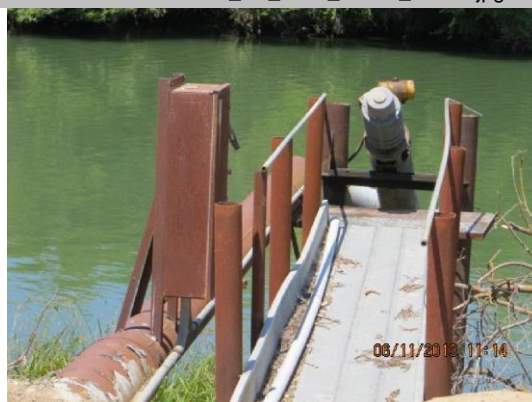
Photo 2 of 3 : UCIP_FA_2018_52755_24549.jpg

Pump and walkway on WS.

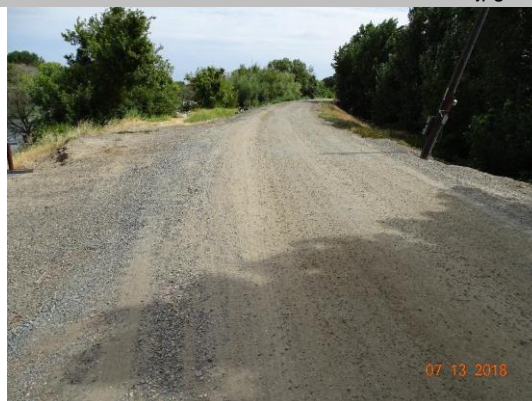
Photo 3 of 3 : UCIP_FA_2018_52755_77745.jpg

View of levee crown at the crossing.

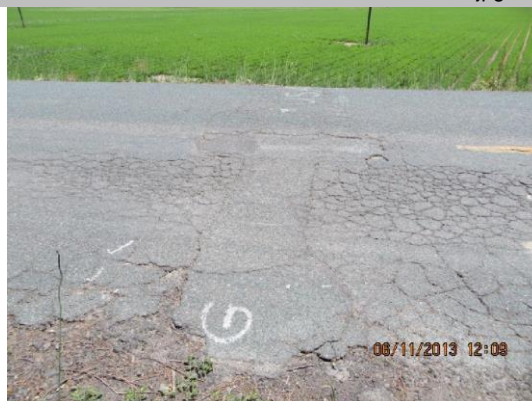
Photo 1 of 3 : UCIP_FA_2018_52758_27390.jpg

Comment Code						
Inspector Comment						
FS_ID:52758 DS_ID:23971 EP_NO: N/A Repair Type: Non-Urgent Crossing Status: Found UCIP Comments: 07/13/2018 Cut-off abandoned, and silted pipe is visible at WS toe. Need a confirmation that pipe through levee was removed. (O.Yakimov-DWR UCIP)06/11/2013 Need to determine disposition of pipe. Likely that this pipe was removed from levee section as evidenced by the cut in pavement on crown. (W.Wylie) FIELD_STRUCT_DESC: 4.5-inch gas line of an unknown material through the levee, at an unknown depth. Cut in pavement and pipe visible on the waterside (WS) toe. (Permit No. 15539 - Pacific Gas and Electric Company [PG&E] [date not indicated in permit]). FS Date: 7/13/2018

Cut in pavement with USAA markings for gasoline.

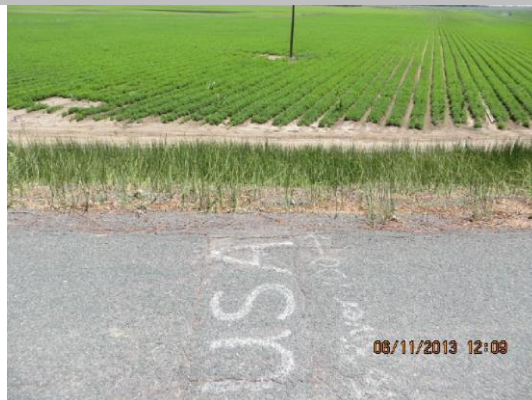
Photo 2 of 3 : UCIP_FA_2018_52758_27389.jpg

Cut in pavement with USAA markings for gasoline.

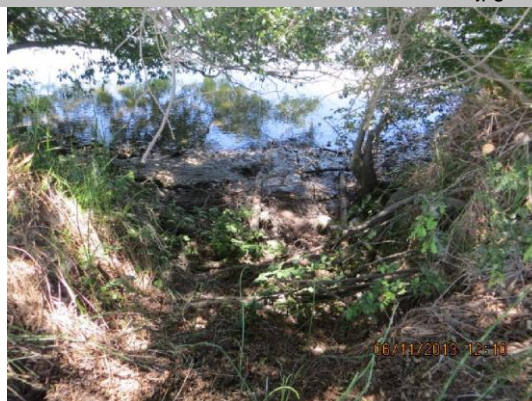
Photo 3 of 3 : UCIP_FA_2018_52758_27388.jpg

Pipe visible on WS toe.

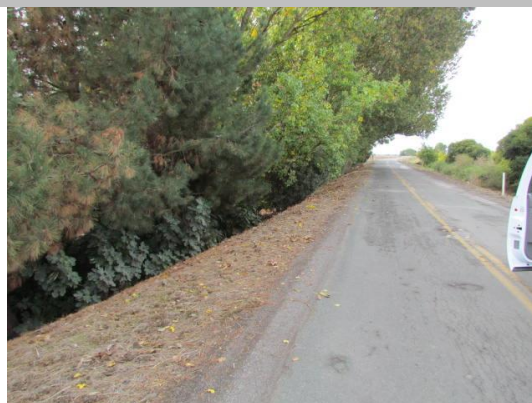
Photo 1 of 1 : FA_2018_RD0563_210_88_20180925_00052.jpg

LM Start	4.63	Rating **	M	Issue No.	88
LM End	4.64	Issue Type +	En	Location *	LS
Category	Earthen Levee			GPS Latitude/Longitude	
				Start	End
Item	Vegetation			38.193078 °	38.192980 °
				-121.551047 °	-121.551263 °
DWR ID	DWR_RD0563_01_s_2012_88				
Comment Code					
V6 : Landscaping					
Inspector Comment					
Fig tree and pine trees block view of landside slope.

Looking south at dense trees on landside slope and toe.

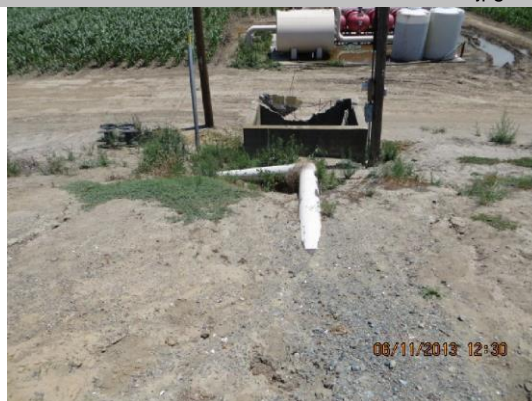
Photo 1 of 3 : UCIP_FA_2018_52761_24590.jpg

Comment Code						
Inspector Comment						
FS_ID:52761 DS_ID:20145 EP_NO: 11205 Repair Type: Non-Urgent Crossing Status: Found UCIP Comments: 07/13/2018 Water pump is running, no leak detected. (O.Yakimov-DWR UCIP)06/11/2013 Some settlement over pipe on WS shoulder and there is some animal burrow tunnels over the pipe on the LS shoulder. (W.Wylie) FIELD_STRUCT_DESC: 10-inch steel irrigation pipe through the levee, 3.8 feet below the crown. Siphon breaker on the landside (LS) shoulder. Slant pump off the waterside (WS) toe. Booster and filter station off the LS toe. Abandoned concrete distribution box at the LS toe. 1-inch galvanized iron electrical conduit through the levee at the same location, at an unknown depth. (Automatic Board Order (ABO) issued as Permit No. 11205, 1975 - Joshua Eppinger Jr.). [Additional Reference(s): DWR Levee Log, 2005. USACE Sacramento O&M Manual 103, June 1954, (Station ""L "" 390+74.5)]. FS Date: 7/13/2018

Pipe, distribution box, JP, electrical conduit, and booster/filter system on LS.

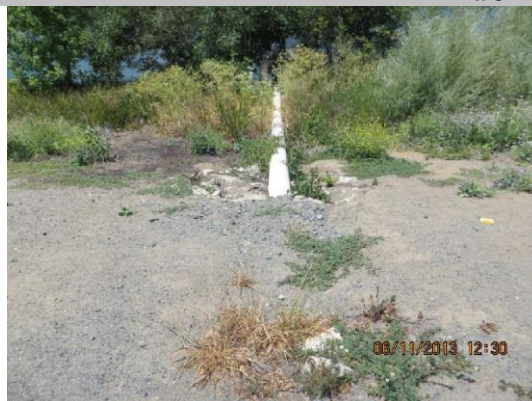
Photo 2 of 3 : UCIP_FA_2018_52761_24589.jpg

Pipe on WS slope.

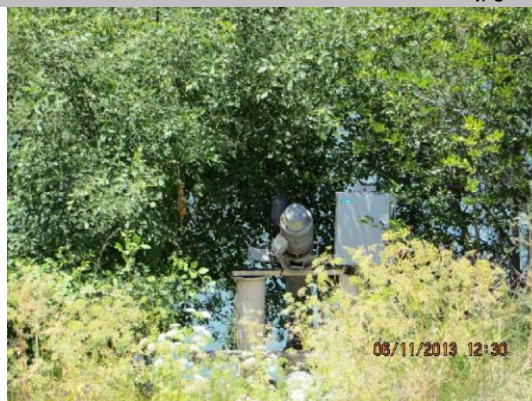
Photo 3 of 3 : UCIP_FA_2018_52761_24588.jpg

Slant pump off WS toe.

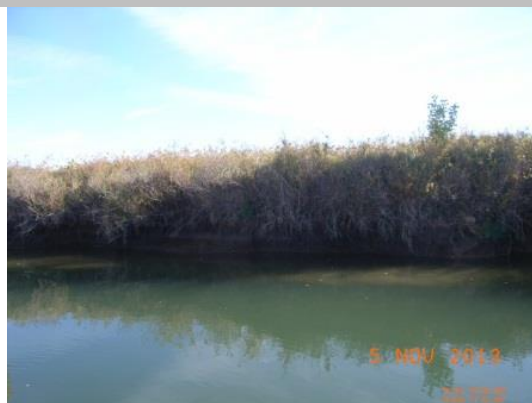
Photo 1 of 1 : FA_2018_RD0563_210_92_20181023_00234.jpg

LM Start	4.98	Rating **	M	Issue No.	92
LM End	5.04	Issue Type +	Ma	Location *	WS
Category	Supplemental			GPS Latitude/Longitude	
				Start	End
Item	2017 USACE Erosion Survey, DRAFT			38.190073 °	38.189524 °
				-121.556307 °	-121.557227 °
DWR ID	DWR_RD0563_01_f_2018_92				
Comment Code					
Inspector Comment					
2017 Site ID: GEO 7.2 L Status: Eroding 2017 Field Notes: New erosion at toe. Site History: 2009 - Small scallops of erosion into the levee toe behind brush boxes. 2011 - Minor new erosion. 2012 - Site extended upstream to account for addition erosion pockets. 2016 - Fresh erosion observed.

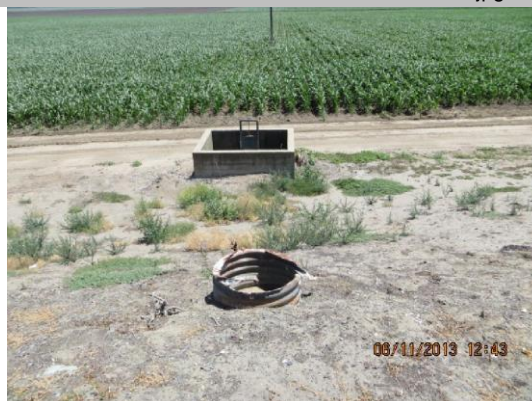
Photo 1 of 3 : UCIP_FA_2018_52763_24595.jpg

Comment Code						
Inspector Comment						
FS_ID:52763 DS_ID:20146 EP_NO: 11205 Repair Type: Non-Urgent Crossing Status: Found UCIP Comments: 06/11/2013 Need to verify wether or not pipe has been abandoned. (W.Wylie) FIELD_STRUCT_DESC: 8-inch steel irrigation pipe through the levee, 3.7 feet below the crown. Pump and gate valve on the waterside (WS) end. Siphon breaker on the landside (LS) shoulder. (Automatic Board Order (ABO) issued as Permit No. 11205, 1975 - Joshua Eppinger Jr.). [Additional Reference(s): DWR Levee Log, 2005. USACE Sacramento O&M Manual 103, June 1954, (Station ""L"" 368+38) 1-inch air valve, brass cock and cover, reinforced concrete spillbox]. FS Date: 7/13/2018

Distribution box and 24-inch CMP riser on LS slope.

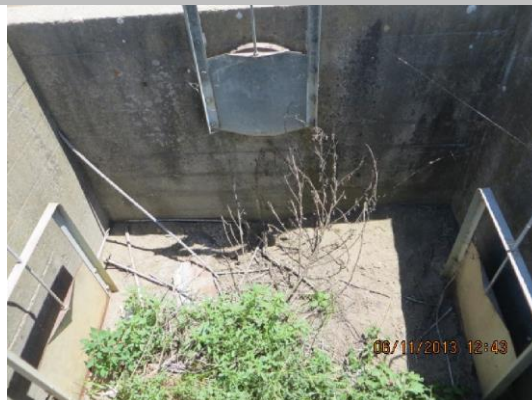
Photo 2 of 3 : UCIP_FA_2018_52763_24594.jpg

Inside distribution box at LS toe.

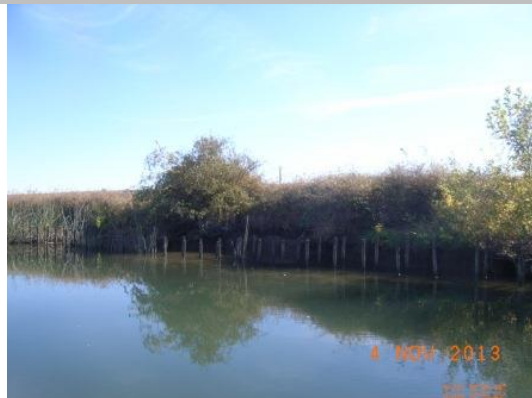
Photo 1 of 1 : FA_2018_RD0563_210_91_20181023_00233.jpg

2017 Site ID: GEO 6.3 L
Status: Critical
2018: Do not see evidence of vertical face erosion from levee hinge. I do not see how this could be rated critical (Djulian).
2017 Field Notes: Upgraded to CRITICAL. Combined with 6.8. Vertical sections from mid slope to toe, vertical face from levee hinge at some locations. Wave/tide erosion at toe, evidence of beavers.
Site History: 1997 - Deep pockets of erosion and narrow berm. Reach is characterized by lots of pockets into the existing berm and/or levee slope. 1999 - Some pockets filled with rock riprap. 2000 - Exposed fabric. 2001 - Staked, low fascine walls at bankline. 2002 - New spot of rock at upstream end. Some new brush boxes. 2005 - Some stone sliding off the underlying geotextile fabric. Some new brush bundles in the brush boxes; some with missing bundles. Some boxes too low relative to high tide. 2009 - Minimal new erosion, site length extended. 2010 - New erosion on downstream end, site extended downstream. 2011 - Sites 6.1. 6.4 and 6.6 were combined. New erosion pockets, site extended to include the erosion in between the old sites. 2012 - Rock has been placed in portions of the bank since last year. 2016 - Site 5.8 was merged with this site due to new erosion connecting the sites.

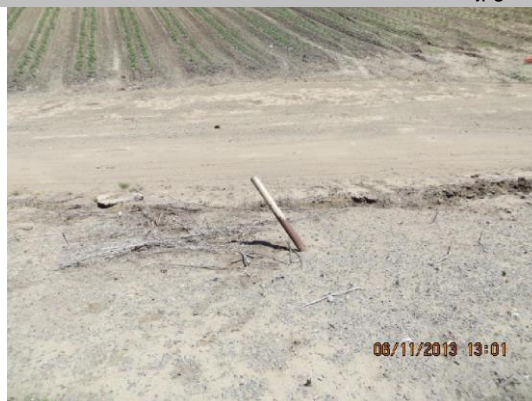
Photo 1 of 2 : UCIP_FA_2018_16289_27439.jpg

LM Start	5.87	Rating **	M	Issue No.	788
LM End	5.87	Issue Type +	En	Location *	
Category	Supplemental			GPS Latitude/Longitude	
				Start	End
Item	DWR UCIP Field Study			38.182398 °	38.182398 °
				-121.569078 °	-121.569078 °
DWR ID	20148				
Comment Code					
Inspector Comment					
FS_ID:16289 DS_ID:20148 EP_NO: 1826 Repair Type: Non-Urgent Crossing Status: Found UCIP Comments: Pipe abandoned and should be done so properly. FIELD_STRUCT_DESC: *ABANDONED* 2-inch discharge pipe of an unknown material through the levee, 2.7 feet below the crown. (Permit No. 1826, 1953 - Brazos Oil and Gas Company). [Additional Reference(s): DWR Levee Log, 2005]. FS Date: 6/11/2013

Pipe visible on LS slope.

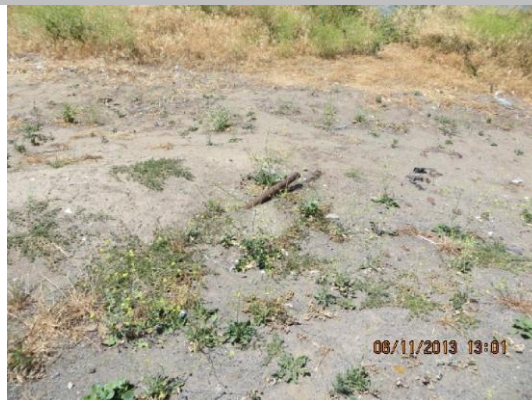
Photo 2 of 2 : UCIP_FA_2018_16289_27438.jpg

Pipe visible on WS shoulder.

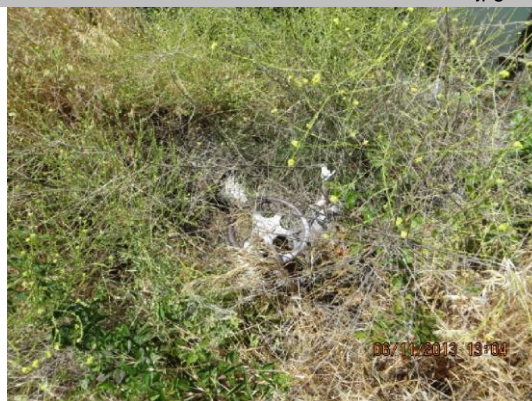
Photo 1 of 3 : UCIP_FA_2018_14949_24603.jpg

Comment Code						
Inspector Comment						
FS_ID:14949 DS_ID:20175 EP_NO: 11206 Repair Type: Non-Urgent Crossing Status: Found UCIP Comments: Pipe appears abandoned and should be done so properly. FIELD_STRUCT_DESC: 1 of 2: 8-inch steel irrigation pipe through the levee, 3.7 feet below the crown. Pump and gate valve on the waterside (WS). Siphon breaker on the landside (LS) shoulder. 7-foot by 9-foot concrete distribution box at the LS toe. (Automatic Board Order (ABO) issued as Permit No. 11206, 1975 - Daniel Faustman). [Additional Reference(s): DWR Levee Log, 2005. USACE Sacramento O&M Manual 103, June 1954, (Station ""L "" 331+00.5)]. FS Date: 6/11/2013

Slide gate at pump on WS slope

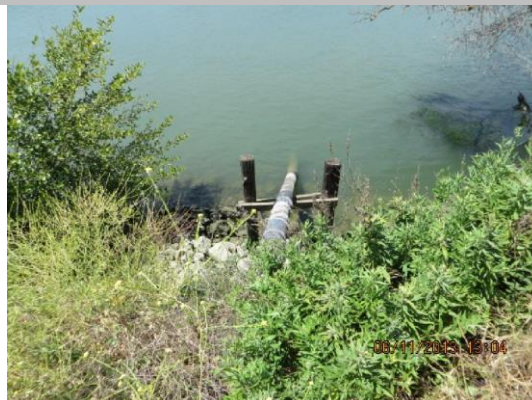
Photo 2 of 3 : UCIP_FA_2018_14949_24602.jpg

Pipe at WS toe.

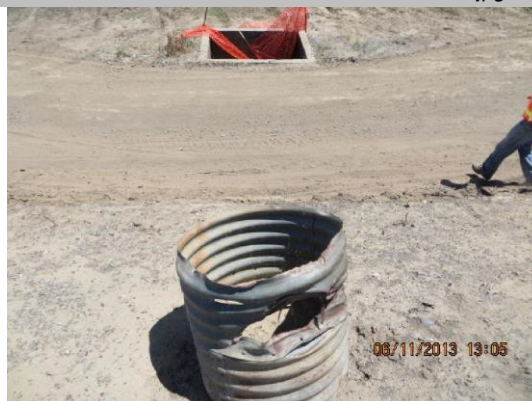
Photo 3 of 3 : UCIP_FA_2018_14949_24601.jpg

Comment Code						
Inspector Comment						
FS_ID:14949 DS_ID:20175 EP_NO: 11206 Repair Type: Non-Urgent Crossing Status: Found UCIP Comments: Pipe appears abandoned and should be done so properly. FIELD_STRUCT_DESC: 1 of 2: 8-inch steel irrigation pipe through the levee, 3.7 feet below the crown. Pump and gate valve on the waterside (WS). Siphon breaker on the landside (LS) shoulder. 7-foot by 9-foot concrete distribution box at the LS toe. (Automatic Board Order (ABO) issued as Permit No. 11206, 1975 - Daniel Faustman). [Additional Reference(s): DWR Levee Log, 2005. USACE Sacramento O&M Manual 103, June 1954, (Station ""L "" 331+00.5)]. FS Date: 6/11/2013

Siphon breaker in 24-inch CMP riser on LS shoulder.

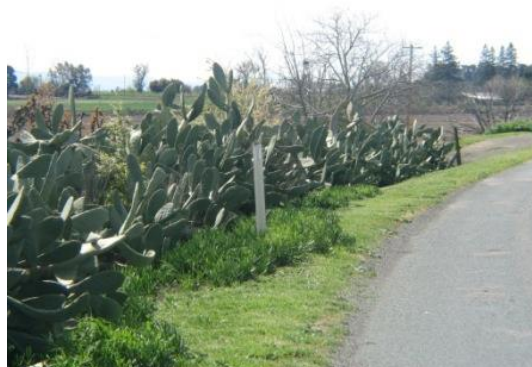
Photo 1 of 2 : FA_2018_RD0563_210_22_20180925_00010.jpg

LM Start	5.92	Rating **	U	Issue No.	22
LM End	5.96	Issue Type +	Ma	Location *	LS
Category	Earthen Levee			GPS Latitude/Longitude	
				Start	End
Item	Vegetation			38.181965 °	38.181763 °
				-121.569913 °	-121.570447 °
DWR ID	DWR_RD0563_01_s_2012_22				
Comment Code					
V2 : Remove the wild growth other than native grasses from the levee slopes.					
Inspector Comment					
Large cactus on landside slope.

Large cactus plant on landward slope from LM 6.04 to 6.08

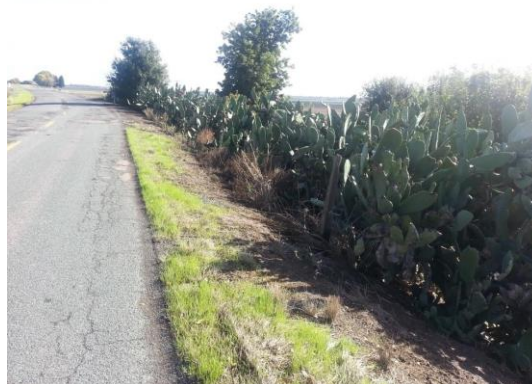
Photo 2 of 2 : FA_2018_RD0563_210_22_20180925_00011.jpg

Looking downstream at dense cactus on landward slope. (Fall 2016)

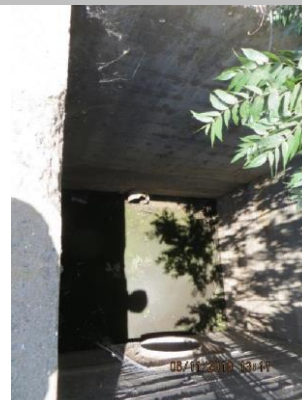
Photo 2 of 3 : UCIP_FA_2018_14950_24606.jpg

Comment Code						
Inspector Comment						
FS_ID:14950 DS_ID:20149 EP_NO: 11206 Repair Type: Non-Urgent Crossing Status: Found UCIP Comments: Need to install a CMP riser on LS shoulder to protect the vent/filler pipe. FIELD_STRUCT_DESC: 2 of 2: 10-inch steel irrigation siphon through the levee, 4.8 feet below the crown. Vent/filler pipe on the landside (LS) shoulder. 7-foot by 9-foot concrete distribution box on the LS toe. (Automatic Board Order (ABO) issued as Permit No. 11206, 1975 - Daniel Faustman). [Additional Reference(s): DWR Levee Log, 2005. USACE Sacramento O&M Manual 103, June 1954, (Station ""L"" 324+07.5) 2-inch air and primer valve, reinforced concrete spillbox]. FS Date: 6/11/2013

Outlet pipe in distribution box on LS toe.

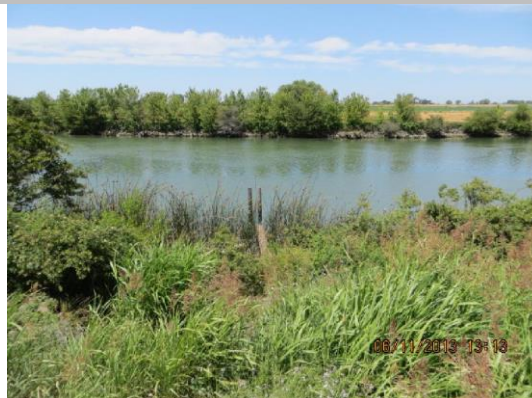
Photo 3 of 3 : UCIP_FA_2018_14950_24605.jpg

Comment Code						
Inspector Comment						
FS_ID:14950 DS_ID:20149 EP_NO: 11206 Repair Type: Non-Urgent Crossing Status: Found UCIP Comments: Need to install a CMP riser on LS shoulder to protect the vent/filler pipe. FIELD_STRUCT_DESC: 2 of 2: 10-inch steel irrigation siphon through the levee, 4.8 feet below the crown. Vent/filler pipe on the landside (LS) shoulder. 7-foot by 9-foot concrete distribution box on the LS toe. (Automatic Board Order (ABO) issued as Permit No. 11206, 1975 - Daniel Faustman). [Additional Reference(s): DWR Levee Log, 2005. USACE Sacramento O&M Manual 103, June 1954, (Station ""L"" 324+07.5) 2-inch air and primer valve, reinforced concrete spillbox]. FS Date: 6/11/2013

Pipe visible on WS toe.

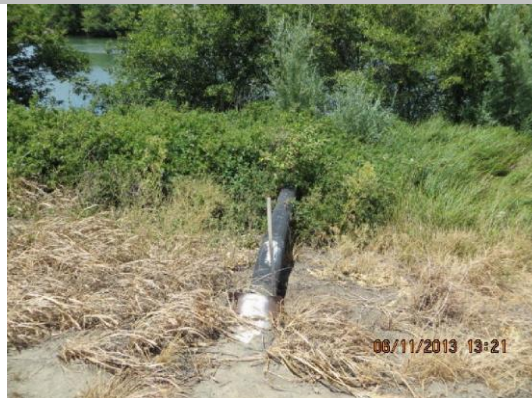
Photo 1 of 3 : UCIP_FA_2018_14963_24622.jpg

Comment Code					
Inspector Comment					
FS_ID:14963 DS_ID:20150 EP_NO: 11200 Repair Type: Non-Urgent Crossing Status: Found UCIP Comments: No permit identified for 10-inch irrigation pipe that is sleeved through the 18-inch. FIELD_STRUCT_DESC: 18-inch steel irrigation pipe through the levee, 5.2 feet below the crown. 10-inch steel irrigation siphon sleeved through the 18-inch pipe. Siphon breaker in a 24-inch corrugated metal pipe (CMP) riser on the landside (LS) shoulder. Air vent on pipe on the LS slope. Slide gate at booster/filter plant off the LS toe. (Automatic Board Order (ABO) issued as Permit No. 11200, 1975 - Cora R. and Furth Brandt). [Additional Reference(s): DWR Levee Log, 2005. USACE Sacramento O&M Manual 103, June 1954, (Station ""L"" 321+03) pipe is plugged]. FS Date: 6/11/2013

10-inch pipe sleeved through 18-inch conduit.

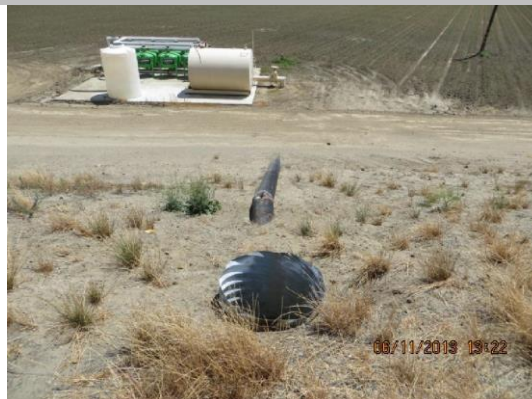
Photo 2 of 3 : UCIP_FA_2018_14963_24621.jpg

Siphon breaker in 24-inch CMP riser on LS shoulder.

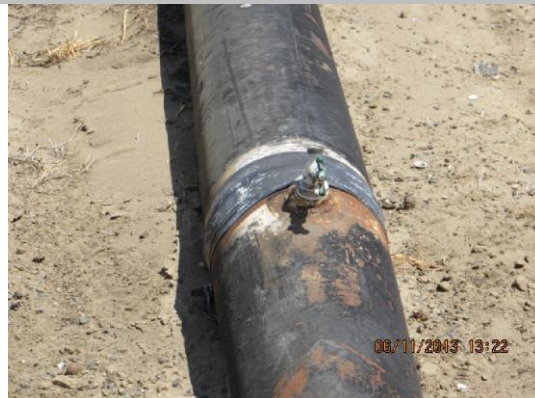
Photo 3 of 3 : UCIP_FA_2018_14963_24620.jpg

Vent/filler pipe on LS slope.

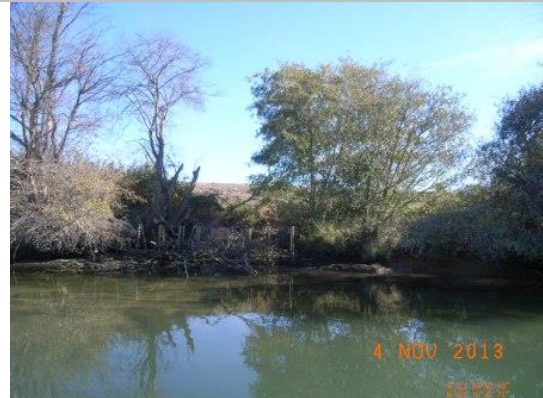
Photo 1 of 1 : FA_2018_RD0563_210_129_20181023_00237.jpg

LM Start	6.38	Rating **	M	Issue No.	129
LM End	6.46	Issue Type +	Ma	Location *	WS
Category	Supplemental			GPS Latitude/Longitude	
				Start	End
Item	2017 USACE Erosion Survey, DRAFT			38.180462 °	38.179319 °
				-121.577895 °	-121.578566 °
DWR ID	DWR_RD0563_01_f_2018_129				
Comment Code					
Inspector Comment					
2017 Site ID: GEO 5.8 L					
Status: Eroding					
2017 Field Notes: Last observed in 2013.					
Site History: 2013 - Erosion pockets into the levee prism. Erosion pockets primarily located behind unmaintained brush boxes.

USACE 2013 Photo #1

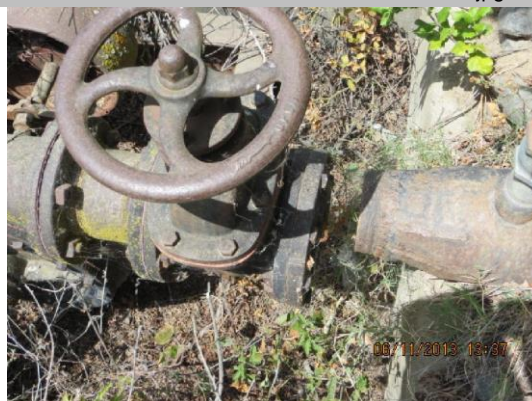
Photo 1 of 3 : UCIP_FA_2018_14966_24628.jpg

LM Start	6.57	Rating **	M	Issue No.	792	
LM End	6.57	Issue Type +	En	Location *		
Category	Supplemental			GPS Latitude/Longitude		
				Start	End	
Item	DWR UCIP Field Study			38.177779 °	38.177779 °	
				-121.578995 °	-121.578995 °	
DWR ID	20152					
Comment Code						
Inspector Comment						
FS_ID:14966 DS_ID:20152 EP_NO: 11201 Repair Type: Non-Urgent Crossing Status: Found UCIP Comments: Appears abandoned and should be done so properly. FIELD_STRUCT_DESC: 3 of 3: 8-inch steel irrigation pipe through the levee, 4.7 feet below the crown. Pump and gate valve on the waterside (WS) berm. 4-foot-diameter concrete standpipe on the landside (LS) toe. Y-ramp on the WS slope. (Automatic Board Order (ABO) issued as Permit No. 11201, 1975 - Joseph Brun). [Additional Reference(s): DWR Levee Log, 2005. USACE Sacramento O&M Manual 103, June 1954, (Station ""L "" 294+25.1)]. FS Date: 6/11/2013

No connection to pump on WS shoulder.

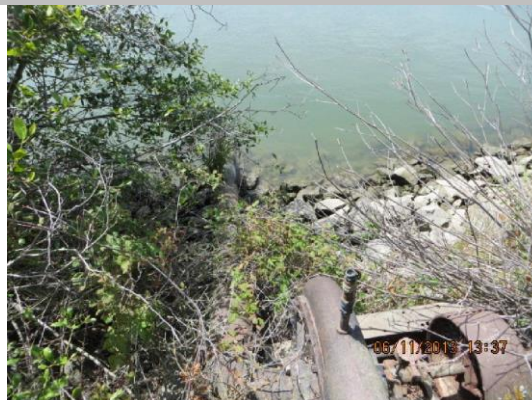
Photo 2 of 3 : UCIP_FA_2018_14966_24627.jpg

Pump and pipe on WS slope.

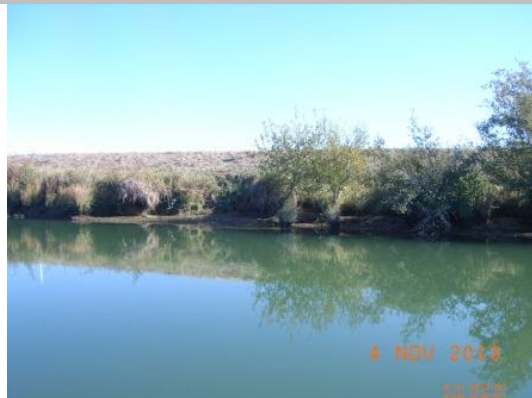
Photo 1 of 1 : FA_2018_RD0563_210_89_20181023_00232.jpg

Comment Code					
Inspector Comment					
2017 Site ID: GEO 5.3 L					
Status: Eroding					
2017 Field Notes: Site extended upstream, increased toe erosion from boat wake/tide action, RD has placed rock on levee slope in places.					
Site History: 1997 - Pocket erosion into the toe of the levee. 2000 - Scallops in banks with small colored flags, biotech rolls present. 2001 - Staked, low fascine walls at bankline. 2003 - Still have visibly bad spots, especially at the upstream end. 2005 - Some new brush bundles in the brush boxes; some with missing bundles. Some boxes too low relative to high tide. 2010 - Site extended upstream. 2011 - Minor new erosion. 2016 - Fresh erosion observed.

USACE 2013 Photo #1

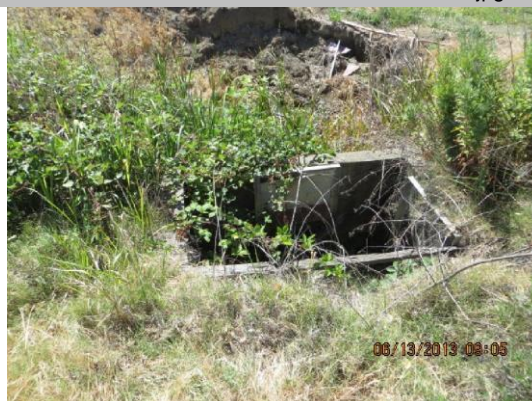
Photo 1 of 3 : UCIP_FA_2018_40790_24633.jpg

Comment Code						
Inspector Comment						
FS_ID:40790 DS_ID:20153 EP_NO: 11202 Repair Type: Non-Urgent Crossing Status: Found UCIP Comments: Pipe appears abandoned and if so should be done so properly. FIELD_STRUCT_DESC: 12-inch steel irrigation pipe through the levee, 4.5 feet below the crown. Vent/filler pipe in a 24-inch corrugated metal pipe (CMP) riser on the landside (LS) shoulder, and a 7-foot by 9-foot concrete distribution box on the LS toe. (Automatic Board Order (ABO) issued as Permit No. 11202, 1975 - Peter L. and Marian M. Campi). [Additional Reference(s): DWR Levee Log, 2005. USACE Sacramento O&M Manual 103, June 1954, (Station ""L"" 289+22.9)]. FS Date: 6/11/2013

7'X9' concrete distribution box on LS toe.

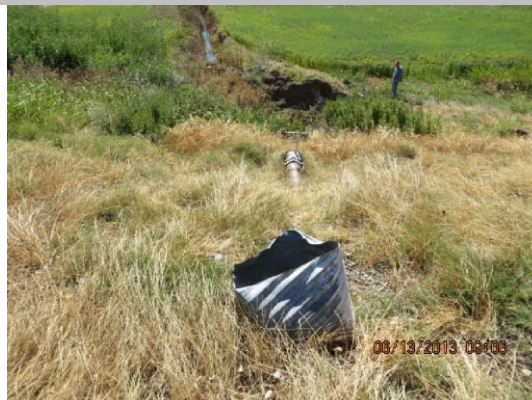
Photo 2 of 3 : UCIP_FA_2018_40790_24632.jpg

24-inch CMP standpipe with vent/filler pipe on LS shoulder.

Comment Code						
Inspector Comment						
FS_ID:40790 DS_ID:20153 EP_NO: 11202 Repair Type: Non-Urgent Crossing Status: Found UCIP Comments: Pipe appears abandoned and if so should be done so properly. FIELD_STRUCT_DESC: 12-inch steel irrigation pipe through the levee, 4.5 feet below the crown. Vent/filler pipe in a 24-inch corrugated metal pipe (CMP) riser on the landside (LS) shoulder, and a 7-foot by 9-foot concrete distribution box on the LS toe. (Automatic Board Order (ABO) issued as Permit No. 11202, 1975 - Peter L. and Marian M. Campi). [Additional Reference(s): DWR Levee Log, 2005. USACE Sacramento O&M Manual 103, June 1954, (Station ""L"" 289+22.9)]. FS Date: 6/11/2013

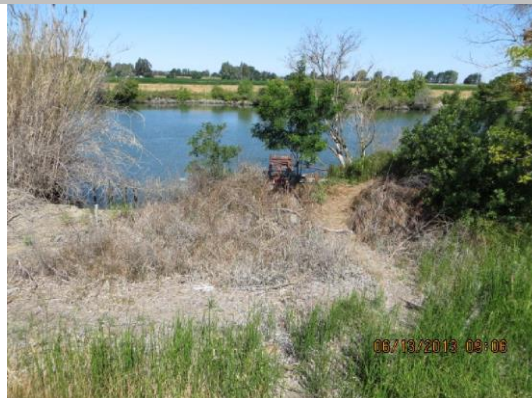
Photo 3 of 3 : UCIP_FA_2018_40790_24631.jpg

Steel walkway support for pipe on WS toe.

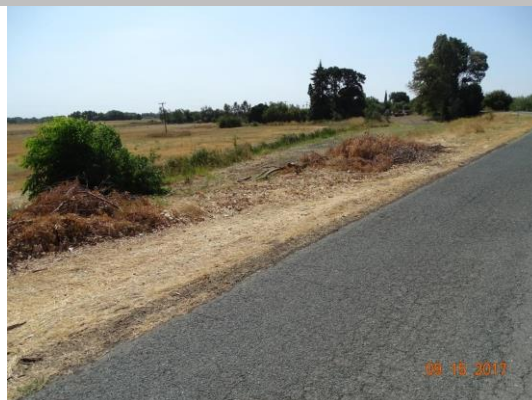
Photo 1 of 1 : FA_2018_RD0563_210_128_20180925_00090.jpg

LM Start	6.67	Rating **	M	Issue No.	128
LM End	6.67	Issue Type +	En	Location *	LS
Category	Earthen Levee			GPS Latitude/Longitude	
				Start	End
Item	Encroachments			38.176387°	38.176387°
				-121.579670°	-121.579670°
DWR ID	DWR_RD0563_01_s_2017_128				
Comment Code					
PR : Prunings					
Inspector Comment					
Broken tree branches and limbs on landside slope.

Looking south at the landside slope.

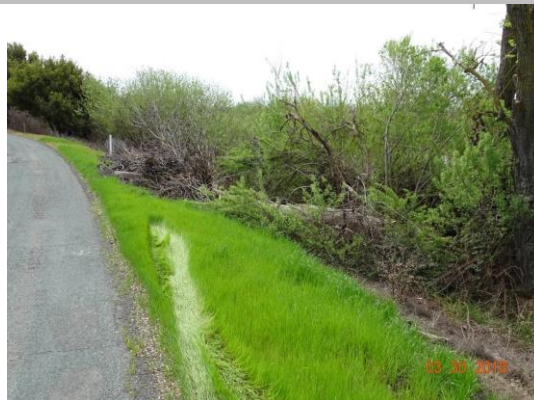
Photo 1 of 1 : FA_2018_RD0563_210_93_20180925_00058.jpg

LM Start	6.74	Rating **	U	Issue No.	93
LM End	6.74	Issue Type +	Ma	Location *	WS
Category	Earthen Levee			GPS Latitude/Longitude	
				Start	End
Item	Encroachments			38.175352 °	38.175352 °
				-121.580177 °	-121.580177 °
DWR ID	DWR_RD0563_01_s_2018_93				
Comment Code					
TR : Tree or limb					
Inspector Comment					
Large fallen tree should be removed from waterside slope and shoulder.

Remove fallen tree from levee slope.

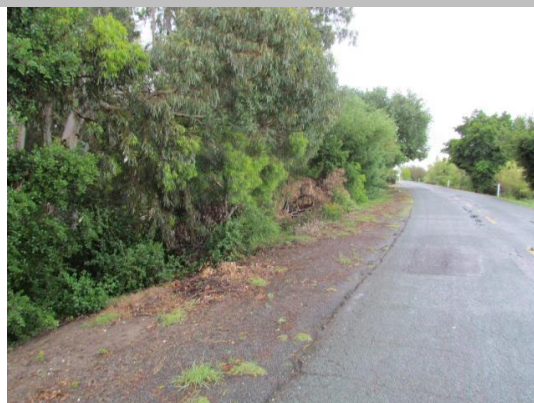
Photo 1 of 1 : FA_2018_RD0563_210_145_20180925_00102.jpg

LM Start	6.75	Rating **	U	Issue No.	145
LM End	6.79	Issue Type +	En	Location *	LS
Category	Earthen Levee			GPS Latitude/Longitude	
				Start	End
Item	Vegetation			38.175219 °	38.174743 °
				-121.580053 °	-121.580016 °
DWR ID	DWR_RD0563_01_s_2014_145				
Comment Code					
V6 : Landscaping					
Inspector Comment					
Untrimmed trees blocking view of landside toe.

Looking southeast at dense vegetation on landward slope and toe.

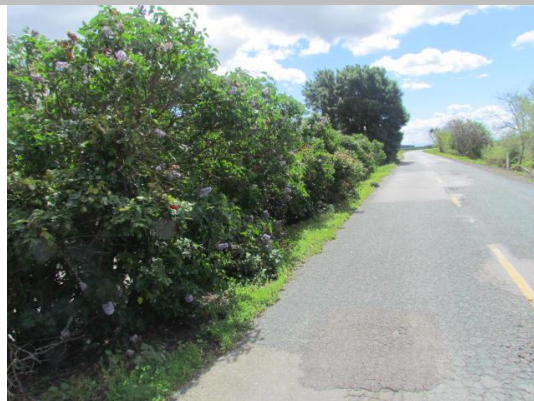
Photo 1 of 1 : FA_2018_RD0563_210_75_20180925_00038.jpg

LM Start	6.80	Rating **	M	Issue No.	75
LM End	6.83	Issue Type +	En	Location *	LS
Category	Earthen Levee			GPS Latitude/Longitude	
				Start	End
Item	Vegetation			38.174598 °	38.174125 °
				-121.579972 °	-121.579892 °
DWR ID	DWR_RD0563_01_s_2013_75				
Comment Code					
V6 : Landscaping					
Inspector Comment					
Dense landscaping on landside shoulder,slope and toe.

Looking south at dense landscaping on landward shoulder and slope.
(Spring 2016)*** Location**

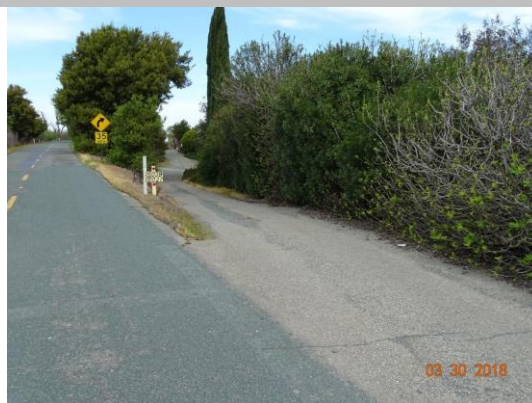
Photo 1 of 1 : FA_2018_RD0563_210_119_20180925_00078.jpg

LM Start	6.84	Rating **	U	Issue No.	119
LM End	6.87	Issue Type +	En	Location *	LS
Category	Earthen Levee			GPS Latitude/Longitude	
				Start	End
Item	Vegetation			38.173912 °	38.173523 °
				-121.579838 °	-121.579737 °
DWR ID	DWR_RD0563_01_s_2018_119				
Comment Code					
V6 : Landscaping					
Inspector Comment					
Thick landscaping prohibits inspection and access.

Thick landside landscaping preventing inspection and access.

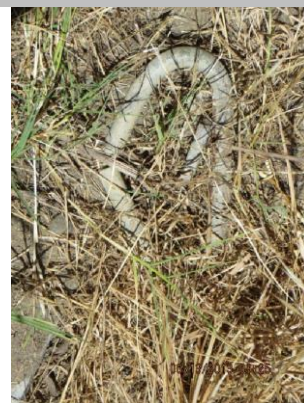
Photo 2 of 3 : UCIP_FA_2018_14968_24636.jpg

Comment Code						
Inspector Comment						
FS_ID:14968						
DS_ID:20154						
EP_NO: 11214						
Repair Type: Non-Urgent						
Crossing Status: Indicator Found						
UCIP Comments: Verify type of abandonment. Wide berm on LS toe with some evidence of steel slide gate in soil at berm.						
FIELD_STRUCT_DESC: 1 of 2: 8-inch steel irrigation pipe through the levee, 3.7 feet below the crown. Siphon breaker on the waterside (WS) slope. (Automatic Board Order (ABO) issued as Permit No. 11214, 1975 - River Island Land Company). [Additional Reference(s): DWR Levee Log, 2005. USACE Sacramento O&M Manual 103, June 1954, (Station ""L"" 269+36) 1-inch air and primer valve, reinforced concrete spillbox].						
FS Date: 6/13/2013

Steel parts on LS toe may indicate location of distribution box.

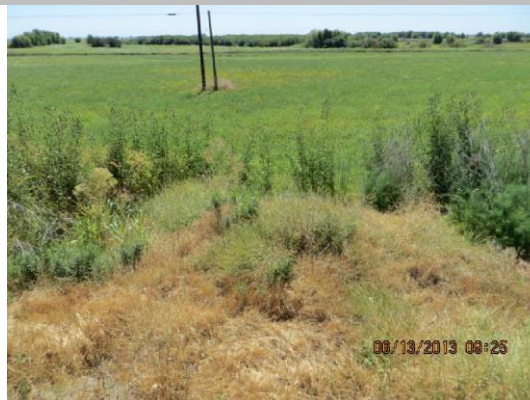
Photo 3 of 3 : UCIP_FA_2018_14968_24635.jpg

Wide berm on LS toe.

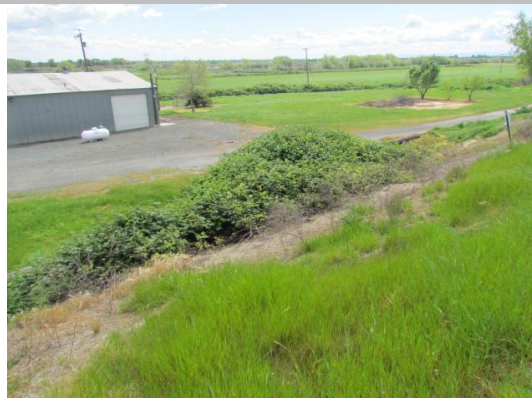
Photo 1 of 1 : FA_2018_RD0563_210_151_20180925_00106.jpg

LM Start	7.07	Rating **	U	Issue No.	151
LM End	7.07	Issue Type +	Ma	Location *	LS
Category	Earthen Levee			GPS Latitude/Longitude	
				Start	End
Item	Vegetation			38.170693°	38.170693°
				-121.579968°	-121.579968°
DWR ID	DWR_RD0563_01_f_2014_151				
Comment Code					
V2 : Remove the wild growth other than native grasses from the levee slopes.					
Inspector Comment					
Dense berryvines at landside toe.

Looking southeast at dense vegetation at landward toe.

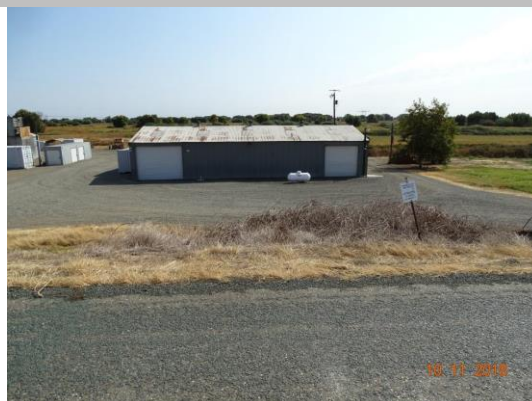
Photo 1 of 1 : FA_2018_RD0563_210_148_20181012_00226.jpg

LM Start	7.14	Rating **	M	Issue No.	148
LM End	7.14	Issue Type +	En	Location *	LS
Category	Earthen Levee			GPS Latitude/Longitude	
				Start	End
Item	Encroachments			38.169717 °	38.169717 °
				-121.580328 °	-121.580328 °
DWR ID	DWR_RD0563_01_f_2018_148				
Comment Code					
DE : Debris					
Inspector Comment					
Prunings on land side slope.

View of prunings on land side slope (October 2018).

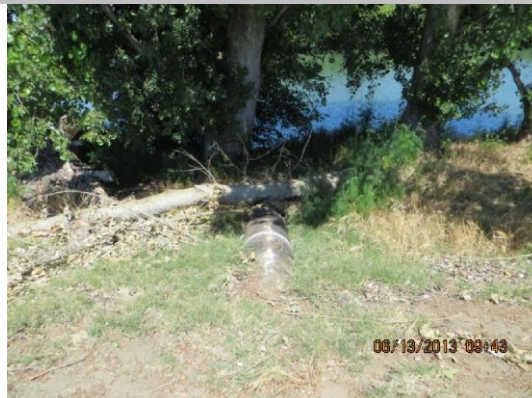
Photo 1 of 2 : UCIP_FA_2018_42743_24641.jpg

LM Start	7.36	Rating **	M	Issue No.	795
LM End	7.36	Issue Type +	En	Location *	
Category	Supplemental			GPS Latitude/Longitude	
				Start	End
Item	DWR UCIP Field Study			38.166832 °	38.166832 °
				-121.582112 °	-121.582112 °
DWR ID	20155				
Comment Code					
Inspector Comment					
FS_ID:42743 DS_ID:20155 EP_NO: 11214 Repair Type: Non-Urgent Crossing Status: Found UCIP Comments: Good candidate for video inspection. FIELD_STRUCT_DESC: 2 of 2: 24-inch steel irrigation siphon through the levee, 0.5 feet below the crown. Vent and filler pipe on the landside (LS) slope. (Automatic Board Order (ABO) issued as Permit No. 11214, 1975 - River Island Land Company). [Additional Reference(s): DWR Levee Log, 2005. USACE Sacramento O&M Manual 103, June 1954, (Station ""L "" 252+40.7)]. FS Date: 6/13/2013

Pipe visible on WS slope.

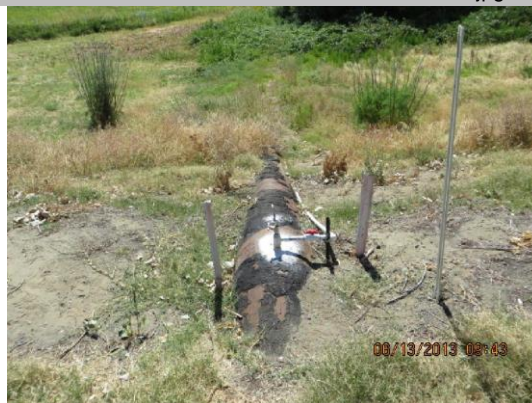
Photo 2 of 2 : UCIP_FA_2018_42743_24640.jpg

Pipe, vent, and filler valve on LS shoulder.

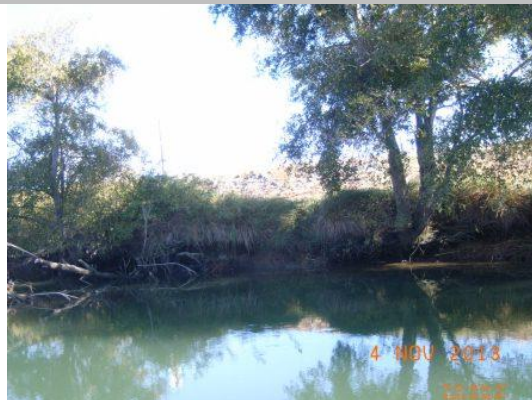
Photo 1 of 1 : FA_2018_RD0563_210_85_20181023_00231.jpg

Comment Code					
Inspector Comment					
2017 Site ID: GEO 4.5 L					
Status: Critical					
2018: Erosion happening at berm, 15 to 20' from the levee hinge point from the berm in some places, erosion into levee toe at other spots (Djulian).					
2017 Field Notes: Numerous areas of bank erosion, with vertical sections up to the levee hinge.					
Site History: 1997 - Pocket erosion at upstream end and into the levee toe under the Alder trees. 2003 - New brush boxes with wattles on bank. 2004 - No brush boxes. 2005 - Site extended from the downstream side of the bridge. Whole bank is vertical. 2010 - Some minor new erosion. 2011 - Site upgraded to CRITICAL. New erosion pockets throughout the site. Sites 4.5, and 4.6 were combined. 2016 - Fresh erosion observed.

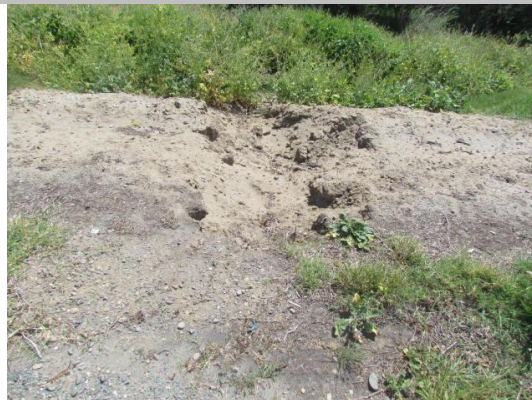
Photo 1 of 1 : FA_2018_RD0563_210_97_20180925_00060.jpg

LM Start	7.62	Rating **	A/W	Issue No.	97
LM End	7.62	Issue Type +	Ma	Location *	LS
Category	Earthen Levee			GPS Latitude/Longitude	
				Start	End
Item	Slope Stability			38.163240 °	38.163240 °
				-121.583328 °	-121.583328 °
DWR ID	DWR_RD0563_01_s_2013_97				
Comment Code					
S1 : Repair slope instability.					
Inspector Comment					
Minor erosion on landside shoulder and slope should be monitored.

Looking east at slope erosion on landward shoulder and slope.

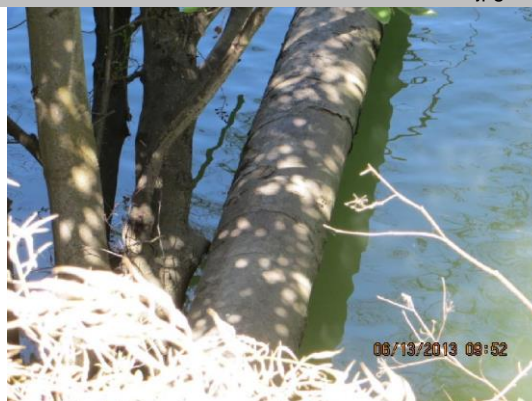
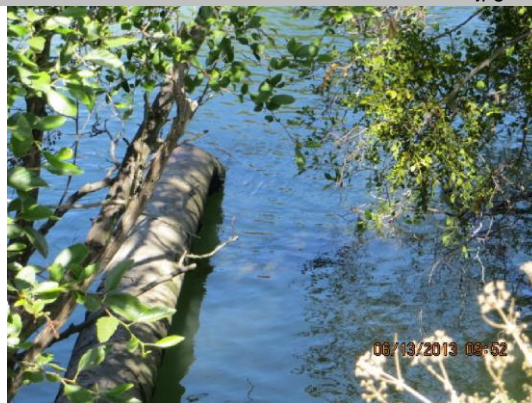
LM Start	7.72	Rating **	M	Issue No.	796	
LM End	7.72	Issue Type +	En	Location *		
Category	Supplemental			GPS Latitude/Longitude		
				Start	End	
Item	DWR UCIP Field Study			38.161873°	38.161873°	
				-121.584109°	-121.584109°	
DWR ID	20185					
Comment Code						
Inspector Comment						
FS_ID:16304						
DS_ID:20185						
EP_NO: N/A						
Repair Type: Non-Urgent						
Crossing Status: Found						
UCIP Comments: Slight depression in crown along pipe alignment may be indication of pipe internal failure. Good candidate for video inspection.						
FIELD_STRUCT_DESC: 14-inch steel irrigation pipe through the levee, 5.1 feet below the crown. [Additional Reference(s): USACE Sacramento O&M Manual 103, June 1954, (Station ""L"" 233+50.5)].						
FS Date: 6/13/2013

Pipe visible on WS toe.

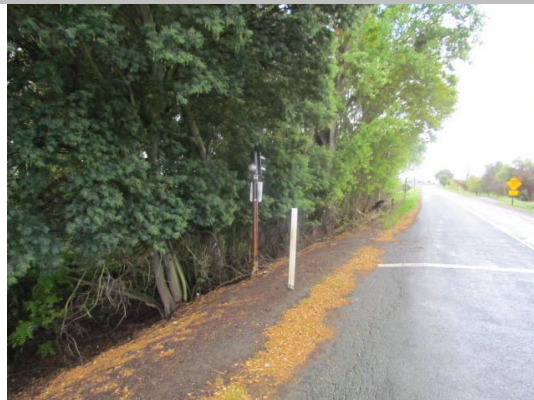
Photo 1 of 1 : FA_2018_RD0563_210_29_20180925_00014.jpg

LM Start	7.74	Rating **	M	Issue No.	29
LM End	7.78	Issue Type +	Ma	Location *	LS
Category	Earthen Levee			GPS Latitude/Longitude	
				Start	End
Item	Trim / Thin Trees			38.161607 °	38.161092 °
				-121.584258 °	-121.584470 °
DWR ID	DWR_RD0563_01_s_2012_29				
Comment Code					
T1 : Trim trees to at least five feet above ground level.					
Inspector Comment					
Dense (untrimmed) trees on landside slope. Branches on ground should also be removed.

Looking southeast at dense trees on landward slope and toe.

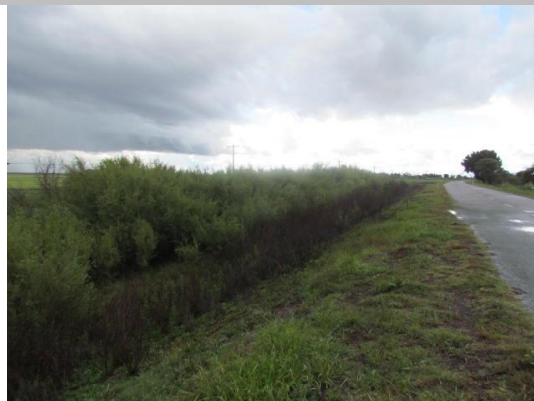
Photo 1 of 3 : FA_2018_RD0563_210_90_20180925_00053.jpg

LM Start	7.80	Rating **	U	Issue No.	90
LM End	7.94	Issue Type +	Ma	Location *	LS
Category	Earthen Levee			GPS Latitude/Longitude	
				Start	End
Item	Vegetation			38.160800 °	38.158922 °
				-121.584598 °	-121.585433 °
DWR ID	DWR_RD0563_01_s_2012_90				
Comment Code					
V2 : Remove the wild growth other than native grasses from the levee slopes.					
Inspector Comment					
Berryvines and willows on landside toe.

Looking southeast at dense vegetation at landward toe. (Spring 2015)

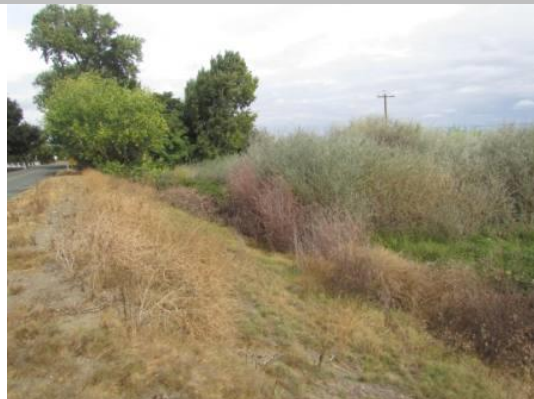
Photo 2 of 3 : FA_2018_RD0563_210_90_20180925_00054.jpg

Looking northeast at dense vegetation on landside toe.

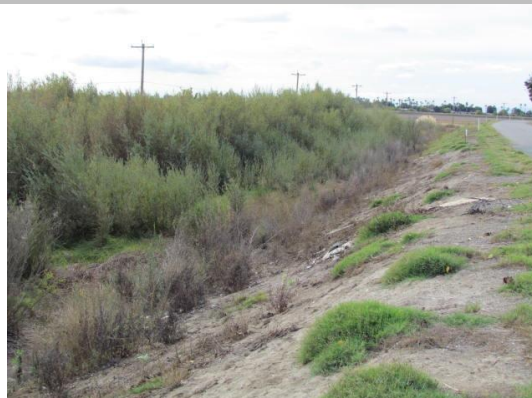
Photo 3 of 3 : FA_2018_RD0563_210_90_20180925_00055.jpg

LM Start	7.80	Rating **	U	Issue No.	90 (cont)	
LM End	7.94	Issue Type +	Ma	Location *	LS	
Category	Earthen Levee			GPS Latitude/Longitude		
				Start		End
Item	Vegetation			38.160800 °		38.158922 °
				-121.584598 °		-121.585433 °
DWR ID	DWR_RD0563_01_s_2012_90					
Comment Code						
V2 : Remove the wild growth other than native grasses from the levee slopes.						
Inspector Comment						
Berryvines and willows on landside toe.

Looking south at dense vegetation on landside toe. (2012 Fall Inspection)

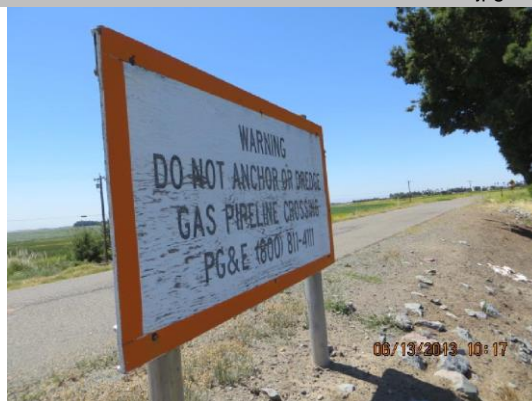
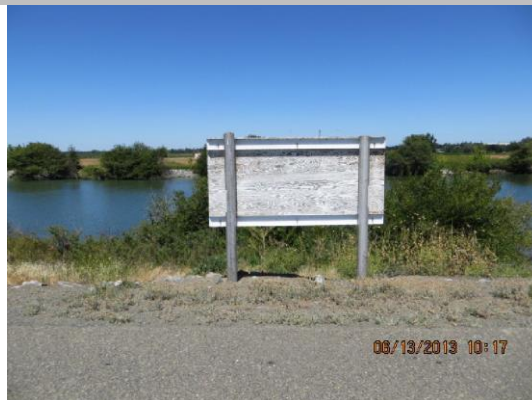
LM Start	7.92	Rating **	M	Issue No.	797	
LM End	7.92	Issue Type +	En	Location *		
Category	Supplemental			GPS Latitude/Longitude		
				Start	End	
Item	DWR UCIP Field Study			38.159207°	38.159207°	
				-121.585304°	-121.585304°	
DWR ID	23973					
Comment Code						
Inspector Comment						
FS_ID:16263						
DS_ID:23973						
EP_NO: N/A						
Repair Type: Non-Urgent						
Crossing Status: Indicator Found						
UCIP Comments: Need to determine disposition of all gas lines in this immediate area.						
FIELD_STRUCT_DESC: Gas line of an unknown size or material through the levee, at an unknown depth. Gas line marker on the WS shoulder.						
FS Date: 6/13/2013

Sign on WS shoulder.

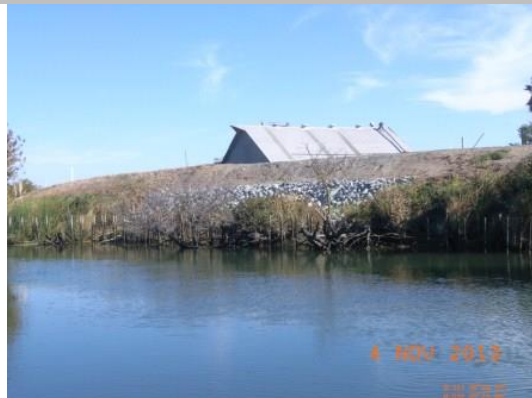
Photo 1 of 1 : FA_2018_RD0563_210_83_20181023_00229.jpg

Comment Code					
Inspector Comment					
2017 Site ID: GEO 3.8 L					
Status: Eroding					
2017 Field Notes: Fresh toe erosion, significant undercutting and slumping.					
Site History: 1997 - Pockets of erosion into the levee at the water line. Alders are being undercut and rotating out into the channel. Damaged rock at upstream end. 2000 - New minor erosion. 2001 - Staked low fascine walls at bankline. 2002 - New "Brush Boxes" along the bank toe. 2003 - New erosion pockets in the middle of the site. 2005 - Some new bundles in the brush boxes. 2011 - Site upgraded to CRITICAL. Significant new erosion. Sites 3.6, 3.7, 3.71, and 4.0 were combined. 2012 - Rock has been placed in some of the erosion pockets since last year, however site remains critical. 2013 - Site no longer critical. The worst pockets were filled with rock by the local RD.

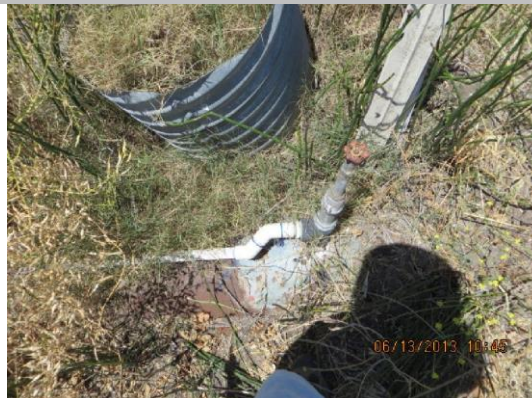
Photo 1 of 3 : UCIP_FA_2018_14988_24670.jpg

Comment Code					
Inspector Comment					
FS_ID:14988					
DS_ID:20160					
EP_NO: 9145					
Repair Type: Non-Urgent					
Crossing Status: Found					
UCIP Comments: Good candidate for video inspection. Erosion in levee adjacent to pipe.					
FIELD_STRUCT_DESC: 2 of 2: 16-inch steel irrigation pipe through the levee, 3 feet below the crown. 14-inch steel irrigation siphon sleeved through the 16-inch pipe with annular space grouted. Air vent/filler pipe on the landside (LS) shoulder with a slide gate in a 48-inch steel standpipe on the LS toe. (Automatic Board Order (ABO) issued as Permit No. 9145, 1973 - care of John Lewallen). [Additional Reference(s): DWR Levee Log, 2005. USACE Sacramento O&M Manual 103, June 1954, (Station ""L"" 212+44.5)].					
FS Date: 6/13/2013

air vent/filler pipe on LS shoulder.

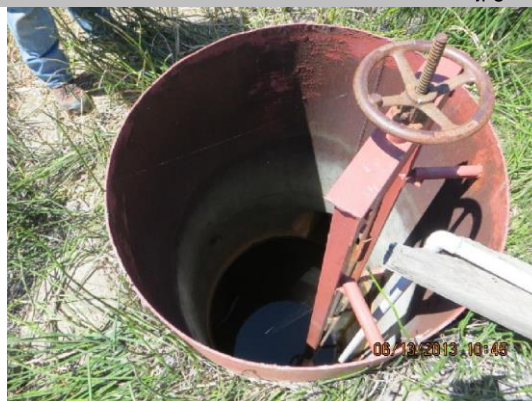
Photo 2 of 3 : UCIP_FA_2018_14988_24669.jpg

Comment Code						
Inspector Comment						
FS_ID:14988 DS_ID:20160 EP_NO: 9145 Repair Type: Non-Urgent Crossing Status: Found UCIP Comments: Good candidate for video inspection. Erosion in levee adjacent to pipe. FIELD_STRUCT_DESC: 2 of 2: 16-inch steel irrigation pipe through the levee, 3 feet below the crown. 14-inch steel irrigation siphon sleeved through the 16-inch pipe with annular space grouted. Air vent/filler pipe on the landside (LS) shoulder with a slide gate in a 48-inch steel standpipe on the LS toe. (Automatic Board Order (ABO) issued as Permit No. 9145, 1973 - care of John Lewallen). [Additional Reference(s): DWR Levee Log, 2005. USACE Sacramento O&M Manual 103, June 1954, (Station ""L "" 212+44.5)]. FS Date: 6/13/2013

Slide gate in steel riser on LS toe.

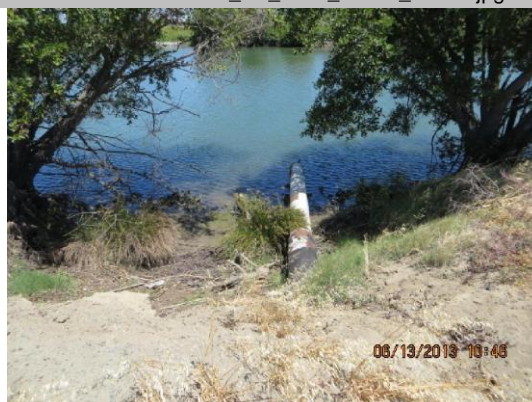
Photo 3 of 3 : UCIP_FA_2018_14988_24668.jpg

Pipe visible on WS toe.

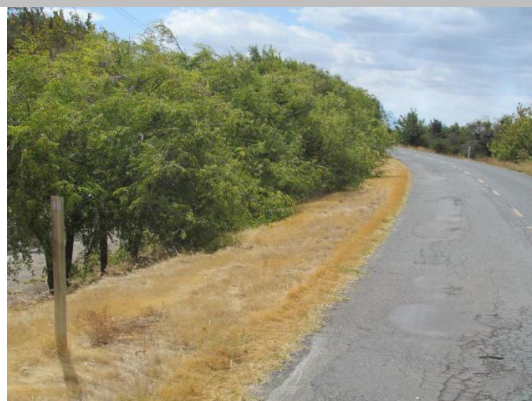
Photo 1 of 1 : FA_2018_RD0563_210_31_20180925_00015.jpg

LM Start	8.38	Rating **	M	Issue No.	31
LM End	8.41	Issue Type +	En	Location *	LS
Category	Earthen Levee			GPS Latitude/Longitude	
				Start	End
Item	Vegetation			38.155974 °	38.155543 °
				-121.591452 °	-121.591595 °
DWR ID	DWR_RD0563_01_s_2012_31				
Comment Code					
V6 : Landscaping					
Inspector Comment

Looking southeast at untrimmed trees on landward slope and toe.

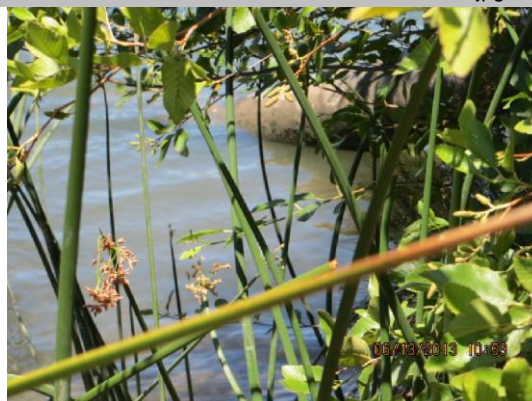
Photo 1 of 3 : UCIP_FA_2018_14990_24677.jpg

Comment Code						
Inspector Comment						
FS_ID:14990 DS_ID:20161 EP_NO: 11217 Repair Type: Non-Urgent Crossing Status: Found UCIP Comments: Pipe appears abandoned and should be done so properly. FIELD_STRUCT_DESC: 1 of 11: 12-inch steel irrigation siphon pipe through the levee, 3.6 feet below the crown. Vent/filler pipe on the landside (LS) shoulder, and a slide gate in a 7-foot by 9-foot concrete distribution box on the LS toe. (Automatic Board Order (ABO) issued as Permit No. 11217, 1975 - Owen E. Wilkenson). [Additional Reference(s): DWR Levee Log, 2005. USACE Sacramento O&M Manual 103, June 1954, (Station ""L "" 193+23.5)]. FS Date: 6/13/2013

Pipe visibel behind trees on WS toe.

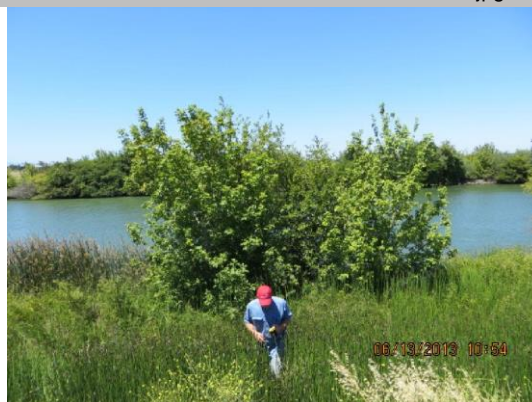
Photo 2 of 3 : UCIP_FA_2018_14990_24676.jpg

Pipe visibel behind trees on WS toe.
